High Tension Inner Coil -  
Lleida, 18-08-2015  
Darrera revisió: 26/01/17  
Apunt nº A-02  
Problemes amb B.Al..  
Total pàgines 2

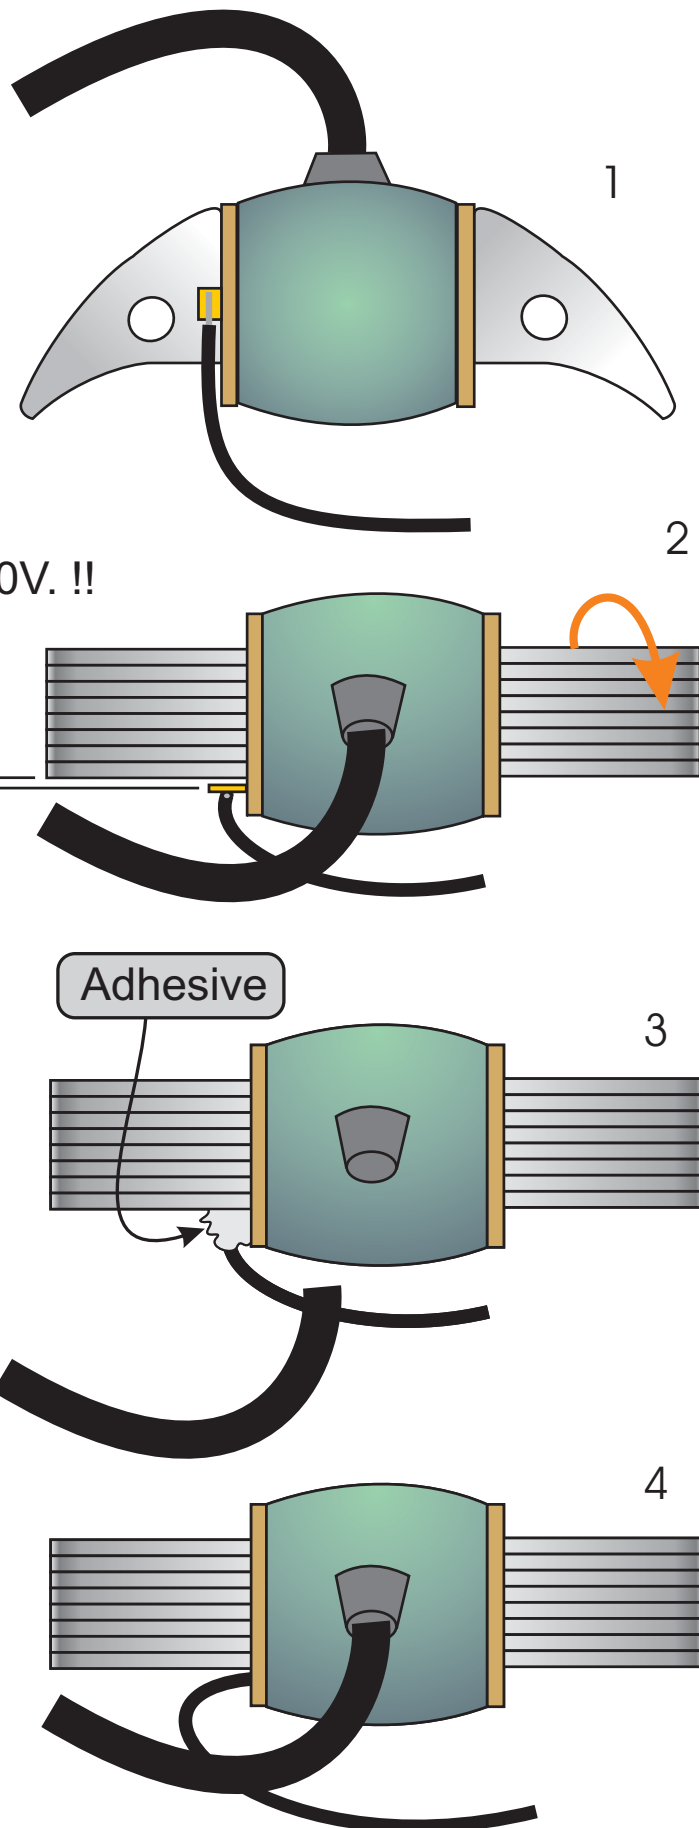
There are certain coils, as in this drawings, that the problem is found in the primari sector coil.

The union, with this sector, is performed in same cases, by rectangular piece that comes out. The tension with our module can reach up to 400V., in the primari circuit, that cover the primari sector coil up to stop push button. You can see that the separation with the metal part is more insufficient. The fact, all the external electric circuit are in most case insufficient for maintain the necessary dielectric stress. For these reason are supplied a variety of electric material with the module.

If your bobbin is made as you can see in thesedrawings, you can perform the solution as thesame manner we could do once time, reflectedin the drawing number 3, by ussing a "Nural 21", having good adhesion to metals and goodinsulation. Any other adhesive with the samecharacteristics can be used. A good manufacturing, you can see on drawing number 4, where the cable exits from inside of the coil.

By immersing the coil in insulating varnish for 24 hours, it may be repaired.
