High Tension Inner Coil -  
Lleida, 18-08-2015  
Darrera revisió: 26/01/17  
Apunt nº A-02  
Problemes amb B.Al..  
Total pàgines 2

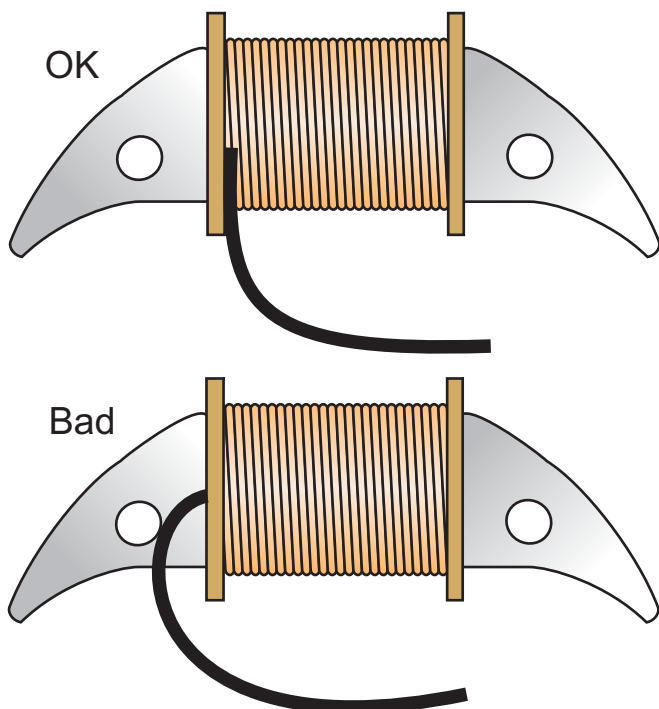
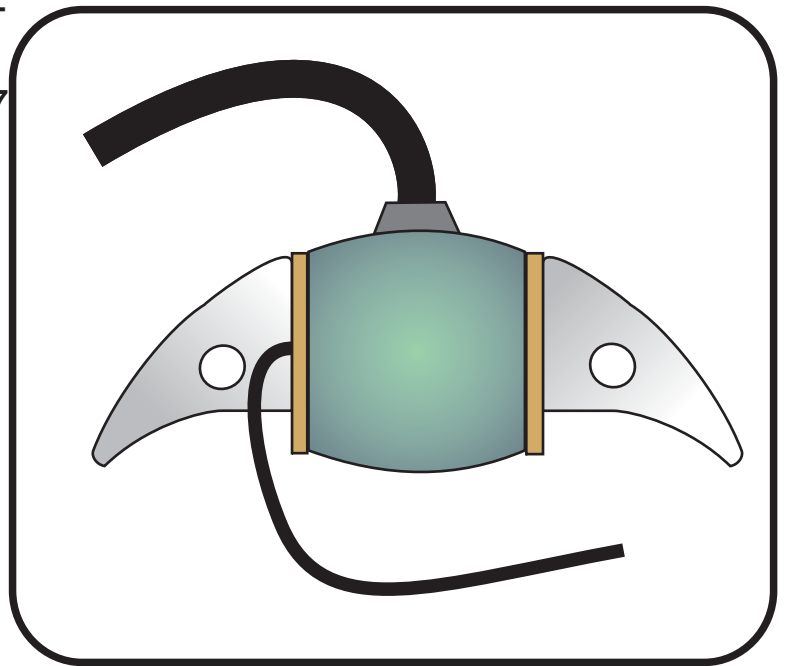
There are certain coils, as in this drawings, that the problem is found in the primari sector coil.

The union, with this sector, is performed in same cases, by rectangular piece that comes out. The tension with our module can reach up to 400V., in the primari circuit, that cover the primari sector coil up to stop push button. You can see that the separation with the metal part is more insufficient. The fact, all the external electric circuit are in most case insufficient for maintain the necessary dielectric stress. For these reason are supplied a variety of electric material with the module.

Unfortunately, sincerely I think that, t the drawings 3 and 4, aren't the perfect solution.

200 to 220 turns  
of 0.6 mm. Approx.  
enamelled copper wire

If your bobbin is made as you can see in thesedrawings, you can perform the solution as thesame manner we could do once time, reflectedin the drawing number 3, by ussing a "Nural 21", having good adhesion to metals and goodinsulation. Any other adhesive with the samecharacteristics can be used. A good manufacturing, you can see on drawing number 4, where the cable exits from inside of the coil.

By immersing the coil in insulating varnish for 24 hours, it may be repaired.
